Tennessee Valley Authority
Office of the Inspector General

Inspection Report

REVIEW OF THE KINGSTON FOSSIL PLANT ASH SPILL ROOT CAUSE STUDY AND OBSERVATIONS ABOUT ASH MANAGEMENT

2008-12283-02
July 23, 2009

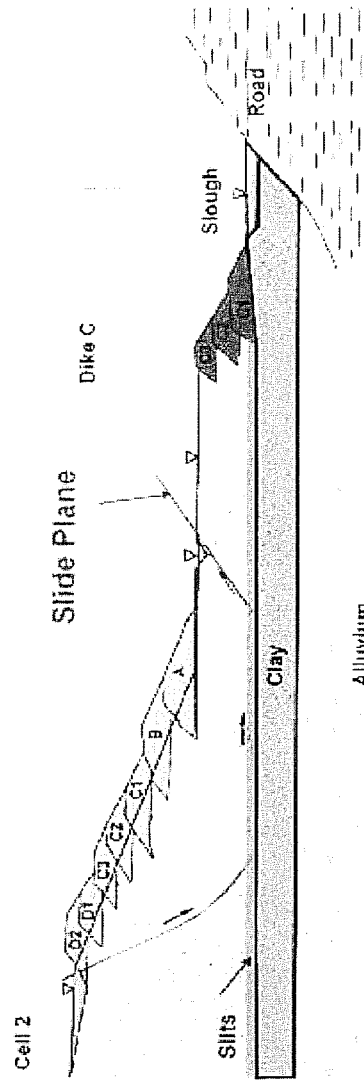
Figure 3

Stage 1 - Initiation of Failure at North Side of Dredge Cell 2

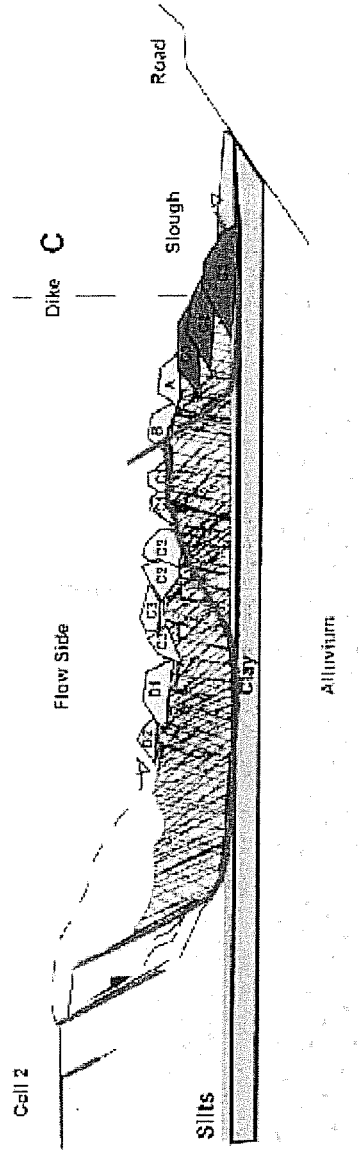
Figure 4

Stage 2 – Ash & Dikes A thru D2 Pile Up Against Dike C. This Surcharge and increased Ash Pressure Causes Dike C to Fail

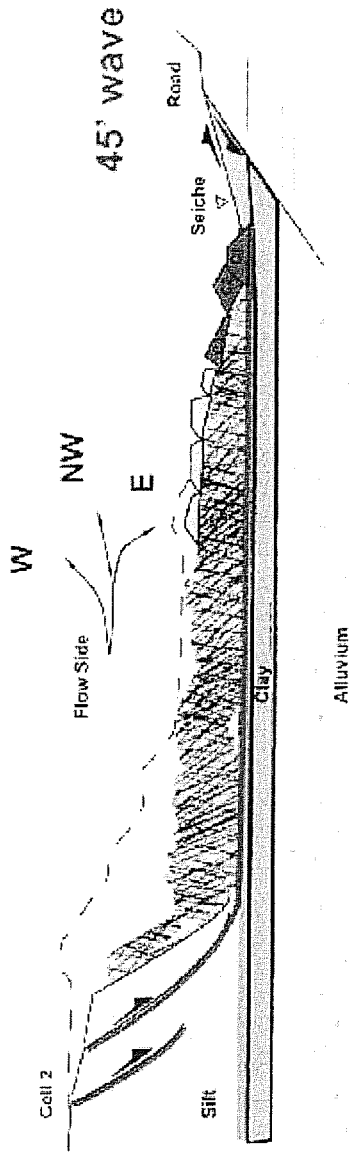
Stage 3 – Progressive Failure Southward that Fails North Dikes A thru D2 Back to Cell 1 Divider Dike. 5.4 Million CY Fill Sloughs and Reservoir

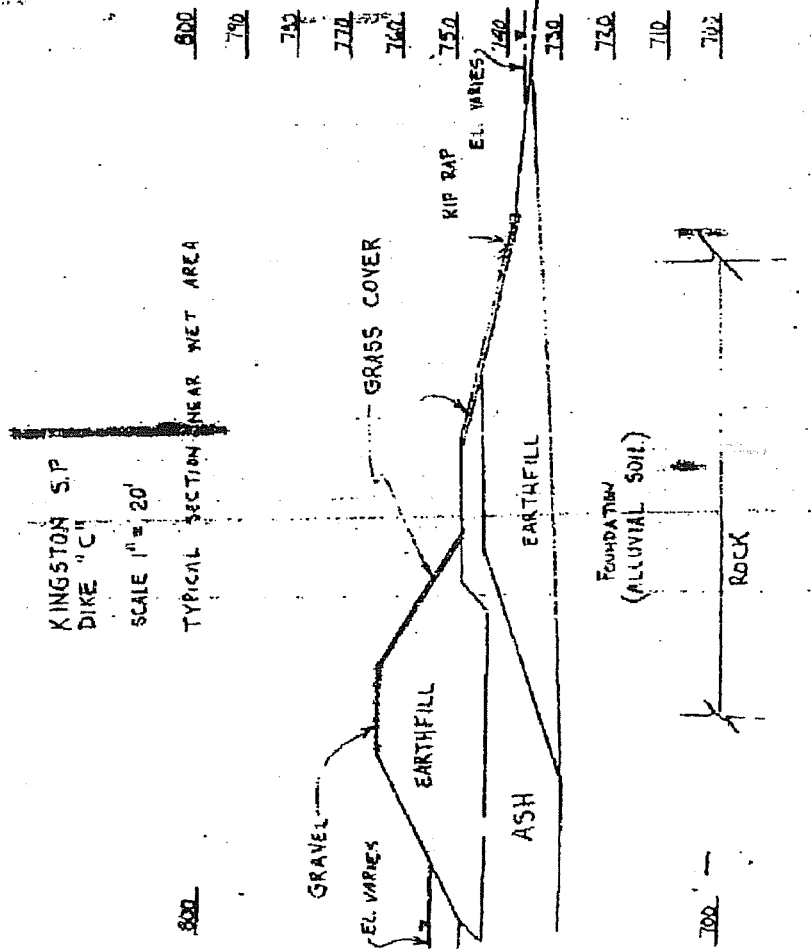
Exhibit 1 - Page 2

TYPICAL SECTION NEAR WET AREA

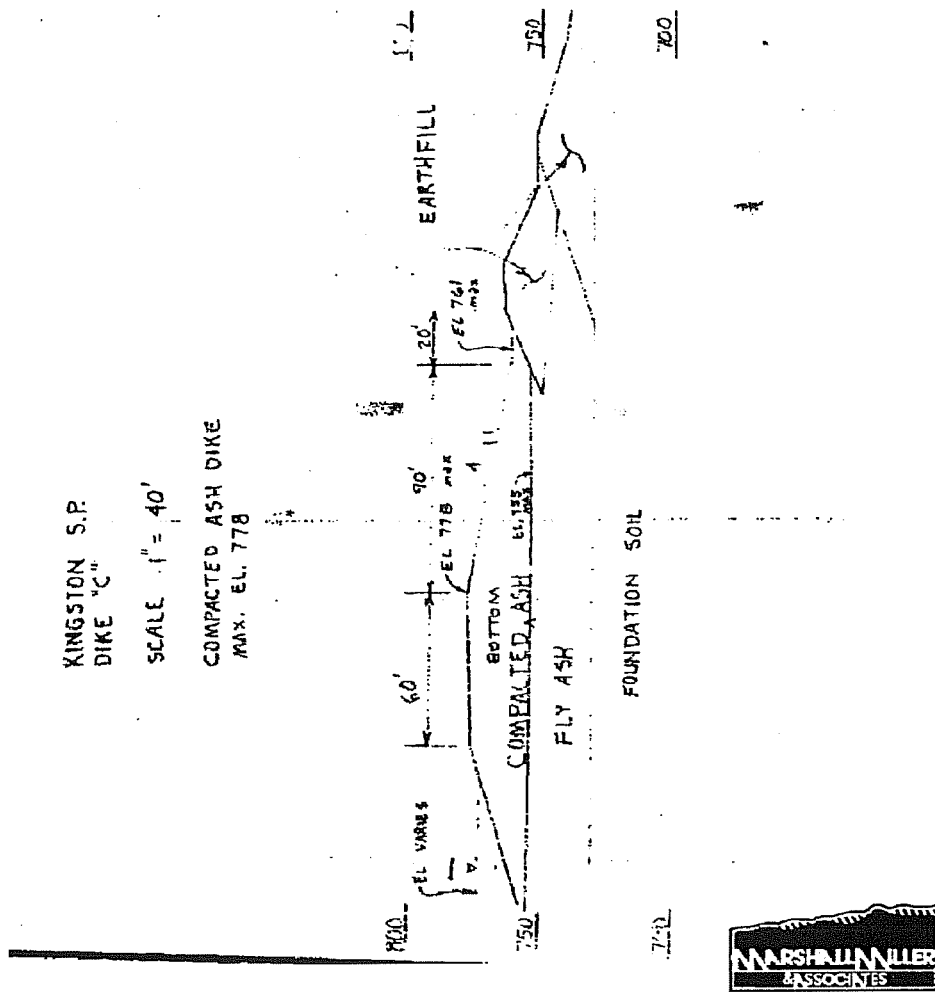
Exhibit 1 - Page 4

KINGSTON S.P.
DIKE "C"
SCALE 1" = 40'
COMPACTED ASH DIKE
MAX. EL. 778
